Design of the Blue Ridge Parkway: Environmental Masterpiece or Standard Road?

Mary Myers, Assistant Professor
Department of Landscape Architecture
College of Design
North Carolina State University
Raleigh, NC 27695

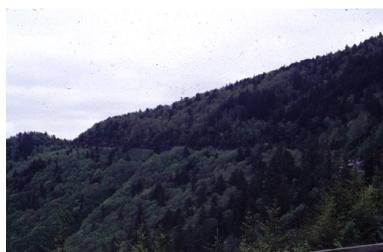
Parkway cut through the Craggies Range

In some places such as in Doughton Park, the road was literally notched into a vertical cliff. In others, it passed through subterranean passages. Blasting and excavation left strata and substrata exposed to erosion and weathering. The consequences were felt when excessive rains caused washouts and rock slides in September 1960, in Buck Creek Gap, NC.

Steep Road Banks A problem in achieving moderate gradient in extreme topography is merging with existing grade. Cuts on the uphill side of the road and fill on the down hill side had to meet existing grade within the parkway right-of-way. This often resulted in extremely steep, unsightly and erosive banks, some in excess of 2:1 ratio. Parkway landscape architects struggled to try to blur the edge between road embankment and natural setting through planting but were not always immediately successful.

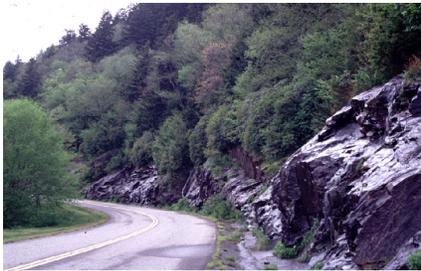
20’ wide parkway motor road with sloping rock adjacent to shoulder

The width of the motor road is narrower than most residential streets: 20 ‘ of paved surface with 5’ grass shoulders on each side. The decision to maintain a

narrow width reduced blasting and earthwork operations.

Rock cuts at the edges of the motorway were designed to try to relate to the natural slope of the mountain. Instead of the straight slice common to highways of the 1930’s and 40’s, the stone was cut to fold back into the mountainside. This would reduce slides and random stone fall. The stone walls were left quite close to the motorway sometimes as close as 5 feet from the edge of the road, a distance considered unsafe in standard highway situations. The decision to retain a limited shoulder zone reduced the amount of excavation. Often that which was left was imposing and added to the feeling of “naturalness” of the parkway. The presence of huge, battered, irregular stone walls within close proximity to the car may serve a safety function by inhibiting speed.
